THE LIONS CLUB
Existing Conditions
and
Redevelopment Options

256 Mammoth Rd, Londonderry, NH 03053

EXISTING CONDITIONS AND REDEVELOPMENT OPTIONS

A. EXISTING BUILDING CONDITIONS - As observed July 20, 2022

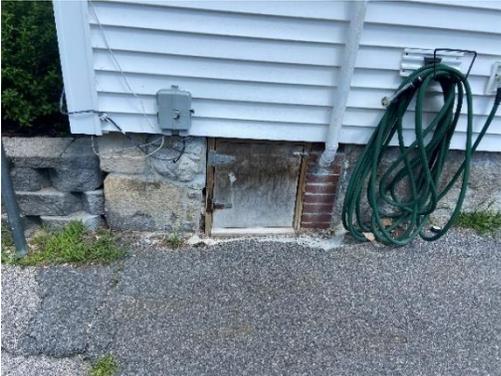
Foundations were not fully observable other than from the surrounding exterior, where granite, field stone, some brick and concrete are visible around the perimeter of the building. There is no basement, although there is some evidence that an access bulkhead may have existed near the current South stairway. The granite block foundations of the main hall and the original front portion of the building appear to be sound, but their depth and bottom bearing conditions could not be verified. However, the visible concrete foundations at added portions of the building, including the rear access ramp and storage room and the south side entry and stair, show some signs of cracking and should be further evaluated for signs of settlement or other distress. The foundation sill plate at the bottom of walls were not visible.

Figure 1.0 foundation access at SE corner

The granite block foundations of the main hall and the original front portion of the building appear to be sound, but their depth and bottom bearing conditions could not be verified. The visible concrete foundations at added portions of the building, including the rear access ramp and storage room and the south side entry and stair, show some signs of cracking and should be further evaluated for signs of settlement or other distress. The sill plate at the wall and foundation interface is likely deteriorated and may require repairs.

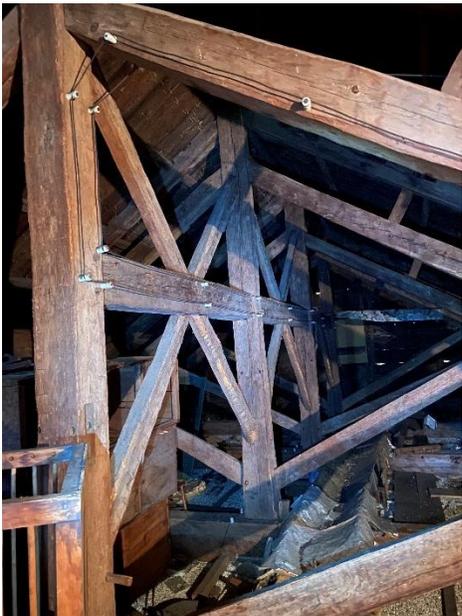
All interior areas are fully finished, although visible framing in the attic indicates wood structural framing throughout. The “Lions Hall”, formerly known as Dr. Morrison’s Meeting House, floor consists of poured concrete footings, wood piers, I-joists, and floor joists throughout the hall covered with plywood subfloor and hard wood flooring. The main roof trusses over the Hall are hand-hewn, dating back to 1769 and are original to the building (although tool marks and joints suggest that some members may have already been recycled at that time). The ceiling in the main hall is bowed; it is not known if the joists above are also bowed or if the suspended ceiling structure itself has sagged over the years.

Figure 2.0 - Attic Structure

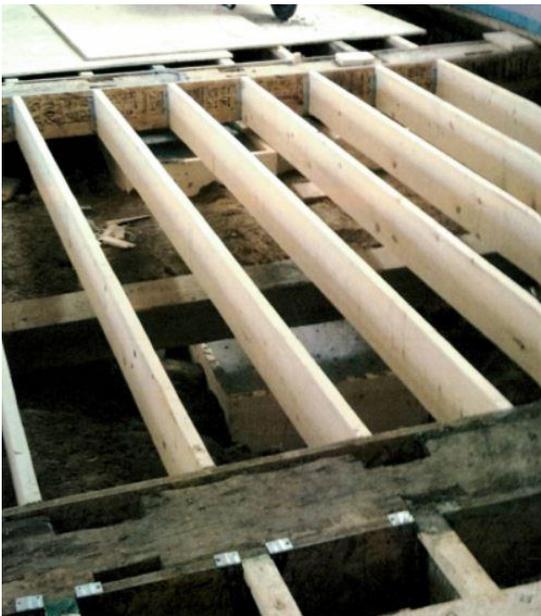
The floor in the main hall has an interior portion with significant deflection (in excess of 2”), suggesting local failure of the wood sub framing. Additional gaps around the perimeter base trim indicate differential movement of the floor.

Figure 2.1 - Hall Floor Structure

The feasibility of replacing the wood-framed main Hall floor with insulated slab-on-grade and floating engineered hardwood finish floor should be investigated. The replacement of this floor structure is included in the preliminary estimate of construction cost and development budget.

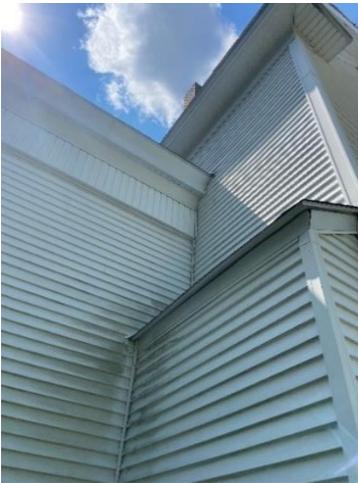
All exterior walls are covered with clapboard-style vinyl siding which is in generally good condition. The configuration and condition of the original wood siding and trim could not be observed, except at some windowsills, where visible deterioration of the underlying wood was noted.

Figure 3.0 – Exterior siding

Walls: Remove the existing vinyl siding and evaluate the condition of the underlying wood siding and trim. Perform structural repairs as needed. Depending on condition, repair and refinish the existing siding and trim; alternatively replace siding and trim with painted fiber-cement (Hardie Board) or similarly durable, low-maintenance alternative. With siding replacement, add continuous insulation layer for code compliance and integration with roof insulation/air barrier system.

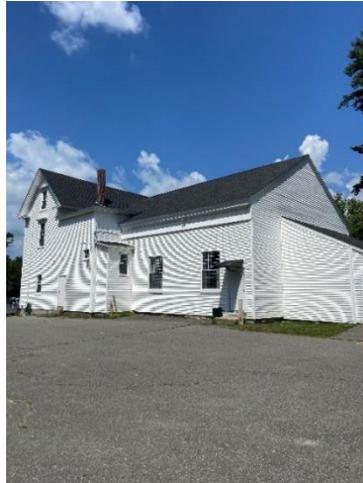
Figure 3.1 – Exterior siding

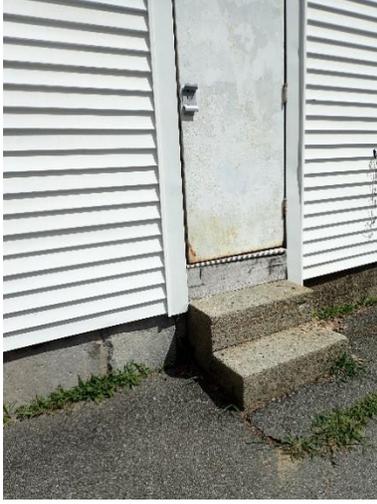
Exterior entry doors are in poor to fair condition. Corrosion of door bottoms and frames was observed. Thresholds do not meet ADA/MAAB accessibility standards. Frames are not thermally-broken.

Figure 4.0 – Exterior side door

Doors and Windows: Replace all with new weathertight, energy efficient units. Windows to have appropriate divided-lite configuration for historical accuracy. All glazing to have low-E coating.

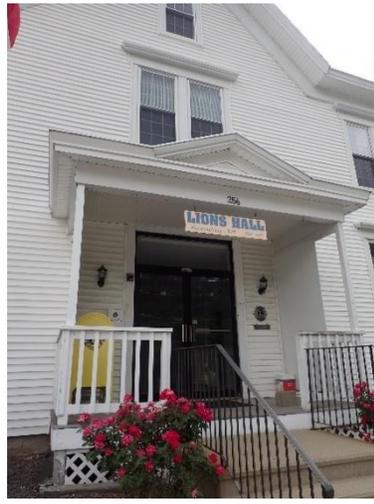
Figure 4.1 – Exterior front door

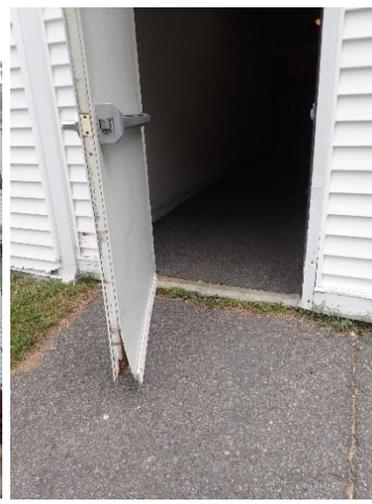
Figure 4.2 – Exterior side door

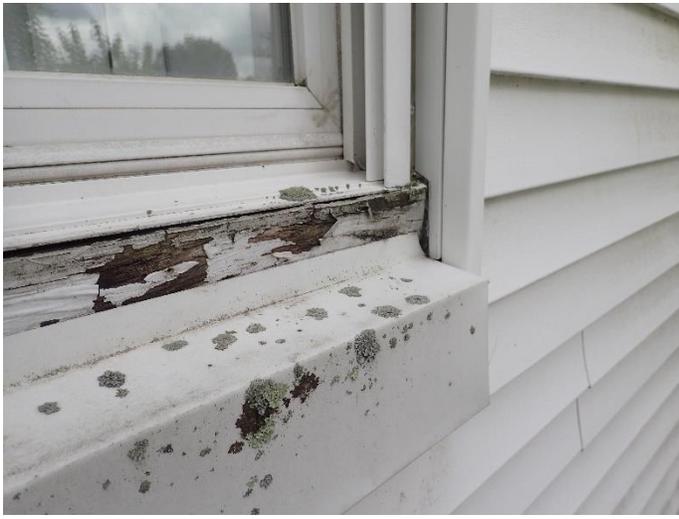
Windows are in fair condition; exposed wood sills show signs of rot throughout the exterior. It is not known if the window frames and/or sash are thermally broken, but their overall performance should be considered marginal.

Figure 5.0 – Exterior window and sill

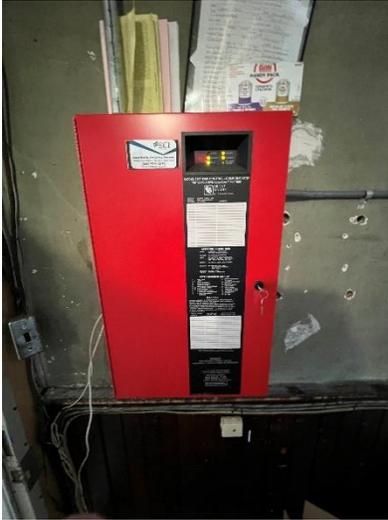
This building does not have a sprinkler system. There is a central fire alarm panel along with smoke detectors observed throughout the building, with emergency lighting and alarm pull boxes at exterior doors.

Figure 6.0 – Fire Control Communicator Box

The building will require a new NFPA compliant sprinkler system. A new water service from the street will need to be provided for a water supply and the existing well will not meet NFPA standard as a source of sprinkler water. It is assumed the Town water supply will be of sufficient capacity to meet NFPA pressure and flow requirements.

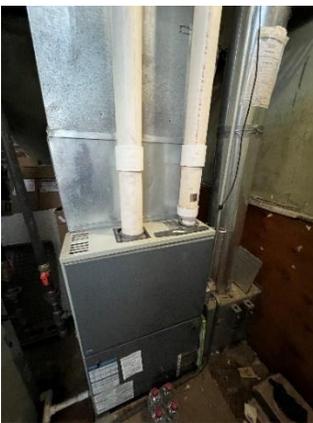
The building has a pair of forced-air direct-vent furnaces heating along with a two-stage non-ducted air conditioning unit that serves the main Hall. No comprehensive fresh-air makeup or exhaust equipment was noted, although ventilation fans at toilet rooms may be present. There is a small exhaust fan at the ceiling of the second-floor meeting room that discharges into the attic space above the main Hall.

Figure 7.0 – Direct-vent Furnace

Remove and replace all Heating, Cooling and Ventilating equipment, distribution, controls, etc.

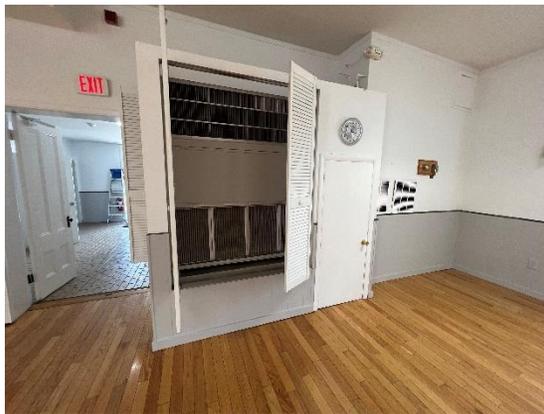
Figure 7.1 – Main Hall Air Conditioning Unit

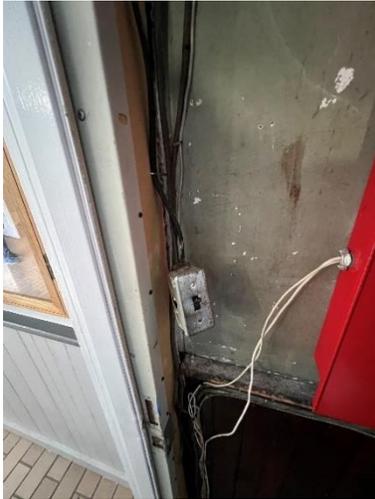
The building has a 200-amp service with multiple sub-panels throughout the building. Abandoned knob and tube wiring is visible throughout the attic space. There are exposed wires connected to devices in the mechanical room and closet spaces, along with open electrical boxes. There are several generations of wiring and device types throughout the building. The condition of conductors and insulation in concealed locations could not be verified.

Figure 8.0 – Exposed wiring Mech. Room

Clean up electrical system- remove outdated wiring and devices, make safe

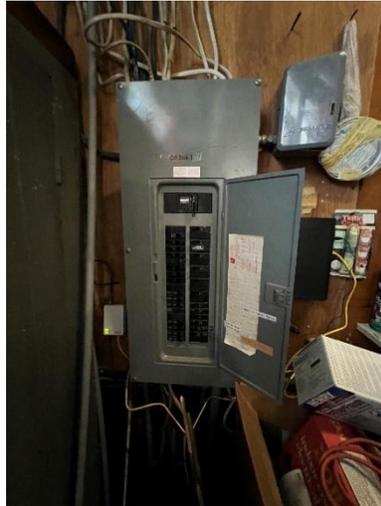
Figure 8.1- Electrical Panel

Remove and replace all electrical service, systems, and distribution,, including lighting, alarms, communications, IT, etc.

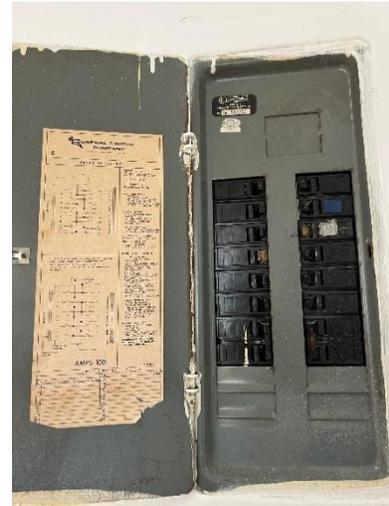
Figure 8.2- Sub Panel

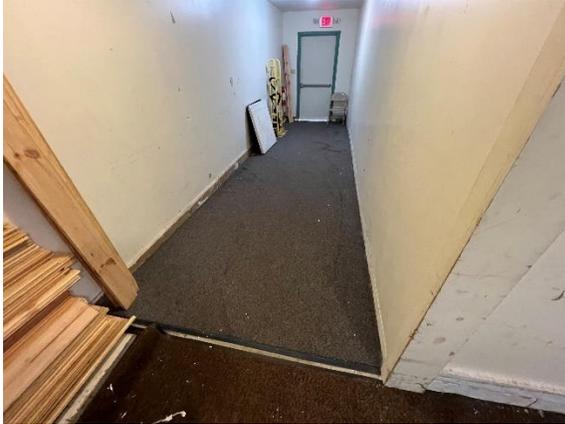
The main entrance is not accessible to persons with disabilities; however, the rear entrance (behind the stage) is at-grade with an interior ramp leading to the main hall. Side doors are not accessible. There is no elevator or chair lift for access to the upper floor. The main Hall stage is stair-access only.

Figure 9.0 – Rear Accessible Entry Ramp, Interior

ADA improvements at existing rear ramp or add new front ramp

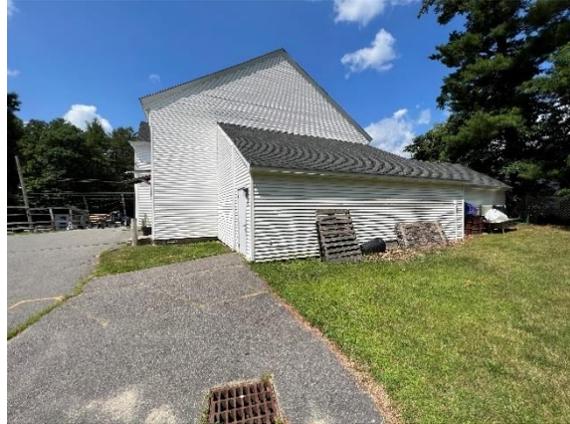
Figure 9.1 – Rear Accessible Entry Ramp, Exterior
